**AUDITOR GENERAL'S DEPARTMENT  
PERFORMANCE AUDIT REPORT**

**RADA'S MANAGEMENT  
OF  
THE REHABILITATION OF FARM ROADS**

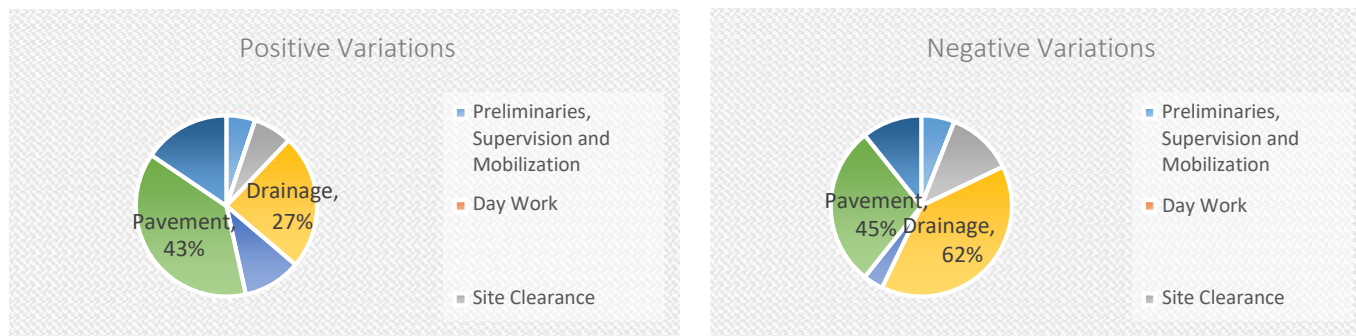
**Figure 5: Categories pavement and drainage show the highest frequency of change**

2.13 In determining the bills of quantity, engineers specified the need for specific works, however, we noted that when final payments were being made<sup>22</sup>, there were changes that resulted in the reduction of critical components of the road, such as drainage and pavement. RADA's records showed that all these re-scoped projects were completed in line with the originally contracted sum, despite the removal of critical elements of the contract. In 53 instances, specification for drainage was either reduced or omitted (**Figure 5**). This, despite RADA's records<sup>23</sup> showing that the entity had identified that the quality of roadwork could be easily undone by rainfall due to inadequate drainage. Along with

maintenance, proper drainage is critical to the longevity and increased value in the rehabilitation of roads.

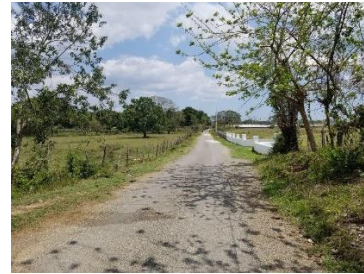
Section of rehabilitated road, Spring Park (St. Elizabeth)

it easier for the farmers to get to and from their farms and buyers, benefitting their families, as well as reducing wear and tear on their vehicles. Despite these benefits, farmers, especially those in St. Elizabeth, identified the lack of proper drainage as continuing to have a significant impact on the recently repaired roads.
